# TIMBER SUPERSTRUCTURES

IL NBI Refresher Course 2024

## Item 59 - Timber Superstructures

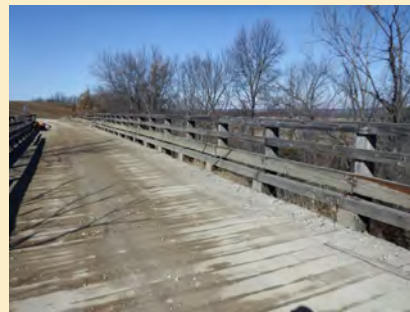
### Common Timber Superstructure Types:

- Solid sawn multi-beam bridges
- Glulam multi-beam bridges
- Trusses and covered bridges

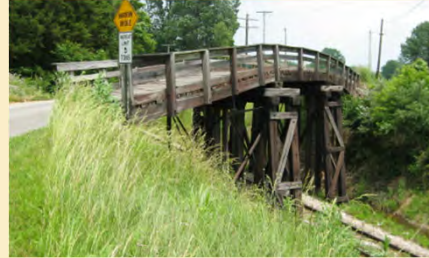
### Solid Sawn Lumber Beams

- This type of bridge has been around for thousands of years!
- Primary members consist of solid sawn or hewn timber
- Short spans on timber or masonry substructures
- Rarely used for vehicle bridges now

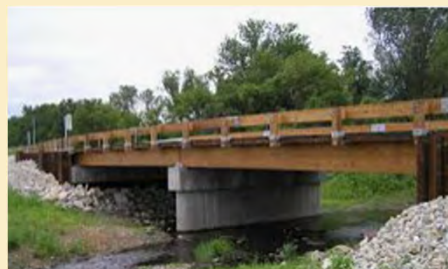
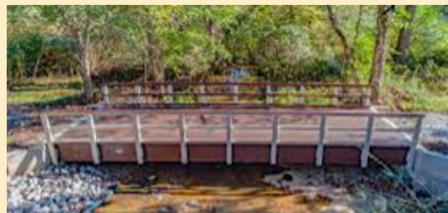
### Glulam Beams

- This type of structure has been around since the 1970's
- Provides greater strength and allows longer spans
- High costs limits use

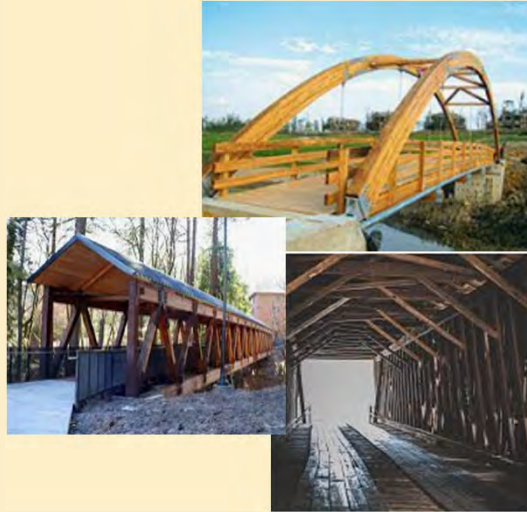
### Truss / Arch / Covered

- Have been in use since at least the 1500's
- Primary members can consist of sawn timber or glulam
- Allows for longer spans
- High costs limits use

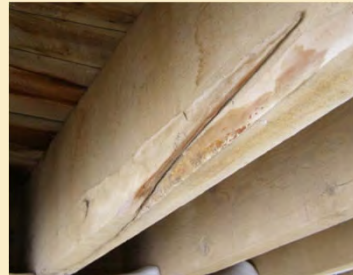
Sketch of Shakes

### Timber Damage - Shakes

- A separation or plane of weakness between growth rings usually caused by events before the wood is milled
- Shakes typically do not have a significant affect on beam capacity
- Severe, deep or long shakes should be documented

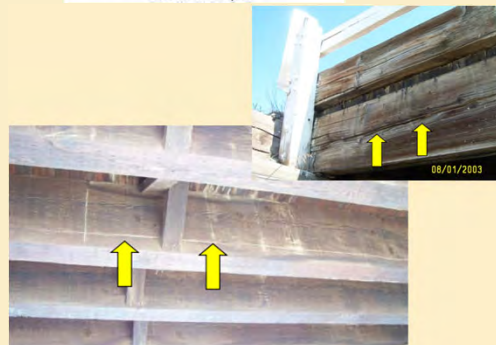
Sketch of a Split

### Timber Damage - Splits

- A check that extends completely thru a member
- It does not propagate thru the top or bottom of the member
- Often caused by seasoning of the wood
- Minor splits typically do not significantly affect the beam capacity of the member (< 20% of member length)

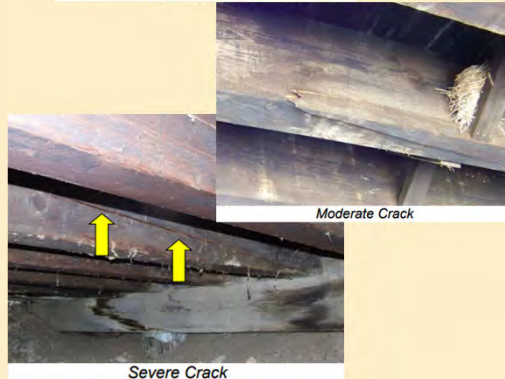
Sketch of a Crack

### Timber Damage - Cracks

- A crack extends completely thru a member, typically starting in the tension portion and extending at an angle away from the tension face
- Often starts in high stress area at a stress riser such as a knot, impact damage or where a check follows the grain to the tension face surface
- Cracks affect the bending capacity of the beam & often lead to breaks
- Repair often required

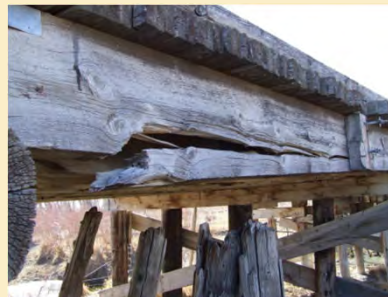
Sketch of a Partial Break

### Timber Damage - Breaks

- Two Types: **Partial** & Complete
- Partial – loss of all strength in a portion of the member's cross section. Important to note the portion of the member that is still intact.
- Significantly reduces beam capacity – repair or replacement required

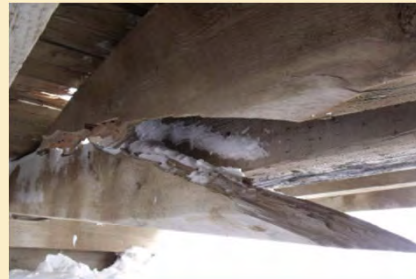
Sketch of a Complete Break

### Timber Damage - Breaks

- Two Types: Partial & **Complete**
- Complete – loss of all strength of a member, extends across the entire member
- Loss of beam capacity – repair or replacement required

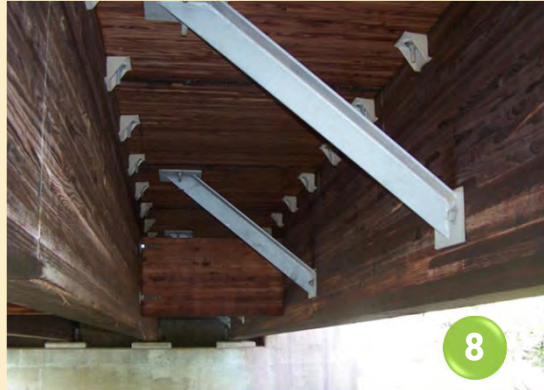
### Very Good Condition

- Timber super and deck
- No significant defects noted
- Not the 1<sup>st</sup> inspection

**VERY GOOD.** May have only **very minor defects** in beams or stringers at non-critical locations.

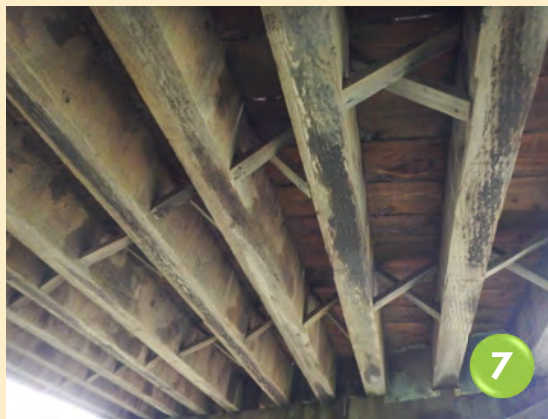
### Good Condition

- Sawn timber super and deck
- Minor checks in timber beams
- No section loss

**GOOD.** **Minor** insignificant decay, **cracking**, or splitting of beams or stringers.

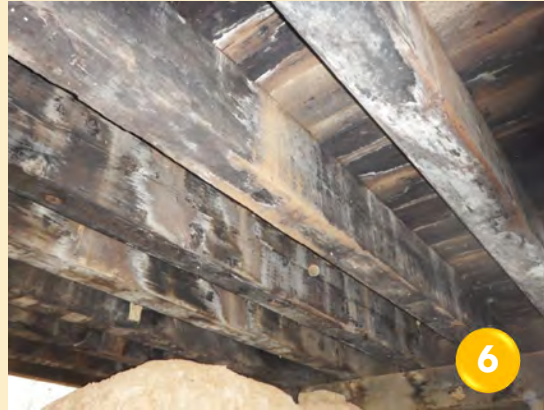
### Satisfactory Condition

- ❑ Sawn timber super and deck
- ❑ Some moderate splitting & checking
- ❑ Minor decay

**SATISFACTORY.** Some decay, cracking, or splitting of beams or stringers may be occurring near the main load carrying portions. Fire damage limited to surface scorching with no significant section loss.

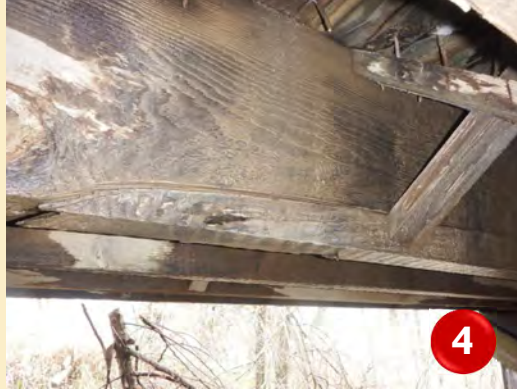
### Poor Condition

- Extensive Crack in timber beam
- 20% loss in cross section

**POOR.** Extensive decay, cracking, splitting or crushing of beams or stringers, or fire damage with main load carrying portions affected. Section loss up to 30%.

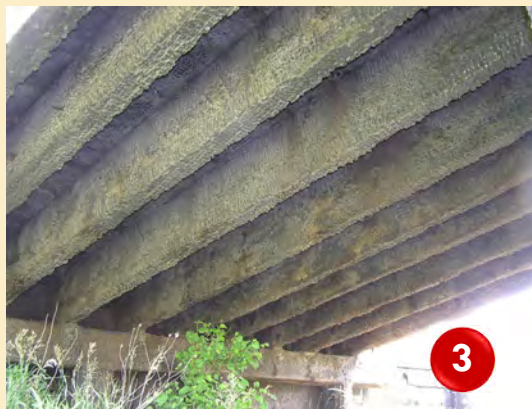
### Serious Condition

- Sawn timber super and deck
- Fire damage
- Section loss at 35% in critical load carrying areas

**SERIOUS.** Severe decay, cracking, splitting or crushing of beams or stringers, or fire damage with major section loss up to 50% in critical load carrying portions of members. A further progression of problems noted for a condition rating of "4".

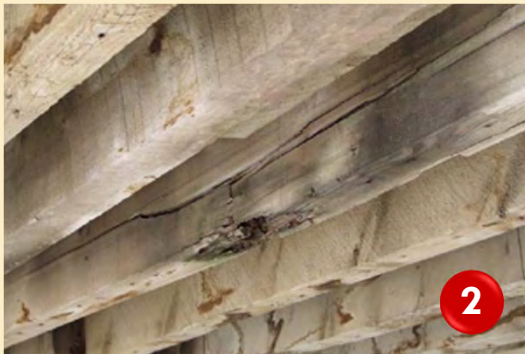
### Critical Condition

- ❑ Sawn timber super and deck
- ❑ Decay & Partial Break of girder
- ❑ Section loss of 80% in critical load carrying area of single beam
- ❑ Multi girder cross section

**CRITICAL.** Beam ends may be crushed or split with settlement of deck. Any **further deterioration of problems noted for a condition rating of "3"**. Section loss over 50%, special feature inspection is required to allow bridge to remain open. The Bureau of Bridges and Structures shall be notified immediately.

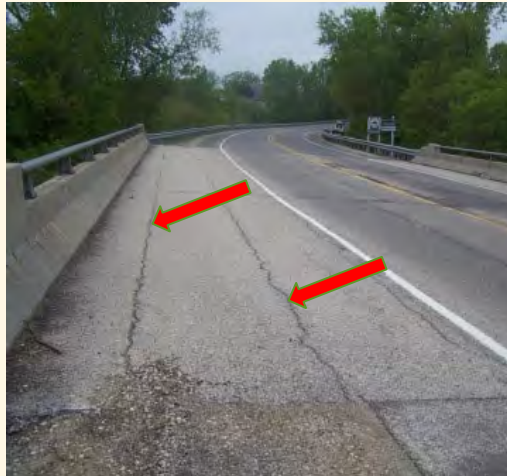
### “Flexible Wearing Surface”

- Deck (Item 58) and Super (Item 59) are rated and coded the same
- Generally consist of bituminous or oil & chip overlays
- Longitudinal Cracks in the overlay usually indicate cracked shear keyways

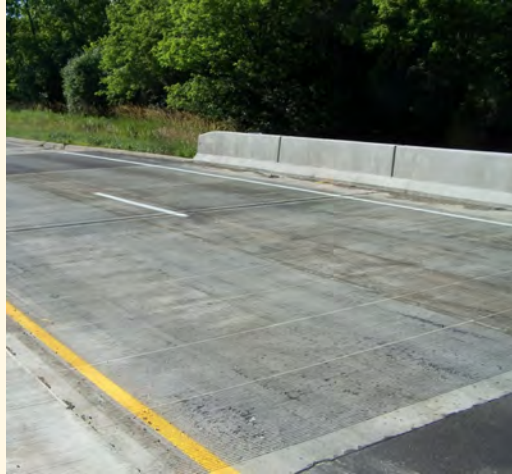
### “Rigid Wearing Surface”

- Thickness of Conc. overlay must be 4” or greater
- Concrete overlay must be reinforced
- Rate the overlay as the Deck (Item 58) and the beams as the Superstructure (Item 59)

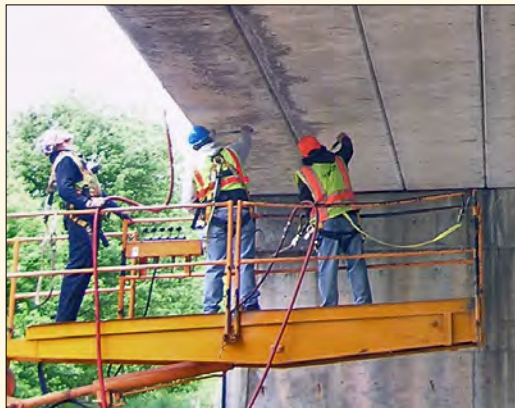
### Sounding

- Use hammer sounding to detect delaminated areas
- Delaminations have a distinctive “hollow or clacking” sound
- Sound concrete has a solid “pinging” sound
- Remove loose & delaminated concrete if practical to reduce the deterioration rate

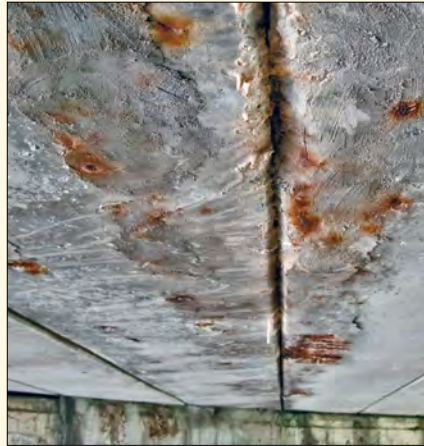
Prestressing strands, reinforcement bars or wire mesh should be considered ineffective in areas where concrete is deteriorated or unsound (delaminated) to the level of the strands, bars or mesh

Post construction repair patches are considered delaminated and the PS strands beneath are considered ineffective

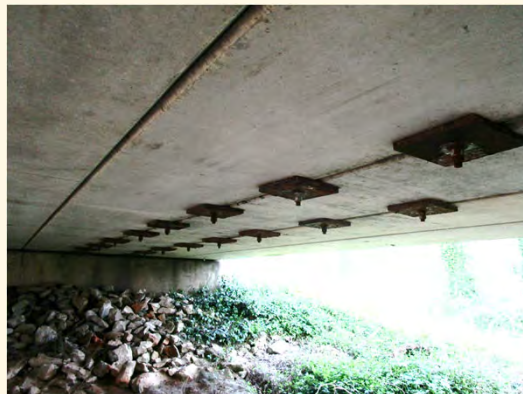
Shear keyway clamps are used at times to remediate differential beam movement

If the clamps are effectively causing the beams to work together and share LL, then they can be considered a good repair

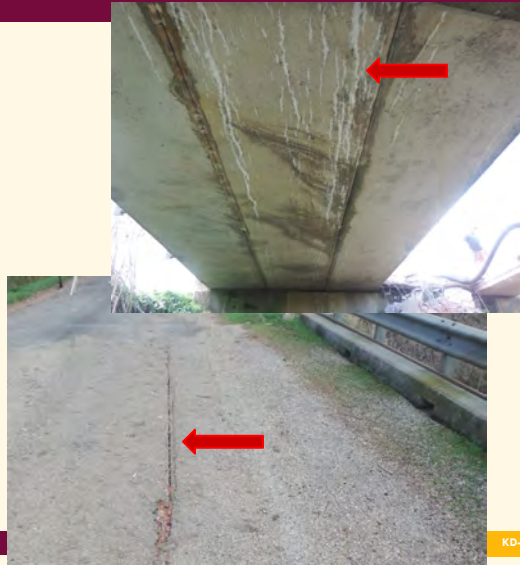
#### PPC Deck Beams - 1 of 2

- Moderate/severe leaching cracks full width of beam
- Sounding indicated not delaminated yet but soft/dull
- Keyways deteriorated
- Not a salted route
- Super was rated a 5 during last inspection
- Beams failed at 2 bridge locations!
- This bridge received multiple loadings from single axle grain wagon prior to failure

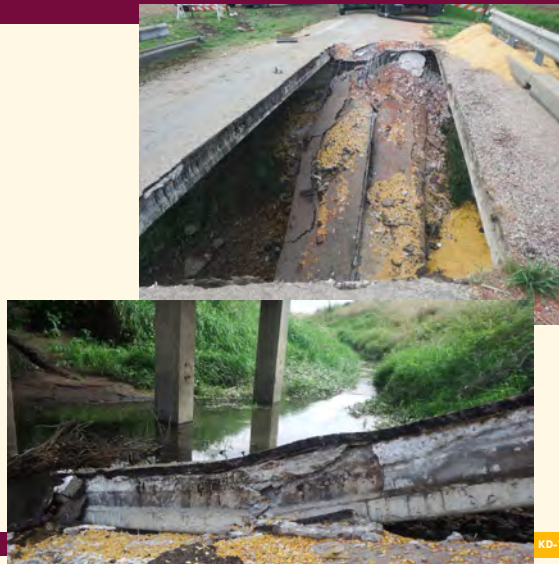
#### PPC Deck Beams - 2 of 2

- Concrete crushed in top of beam, strands looked good
- Beam concrete cores showed strengths of 1.8, 2.8, 3.8 & 7.6ksi for 5.0ksi design strength
- Similar looking beam conditions have been found at other bridges
- Be sure to rate similar beams as if the cracked/leaching areas were delaminated!!

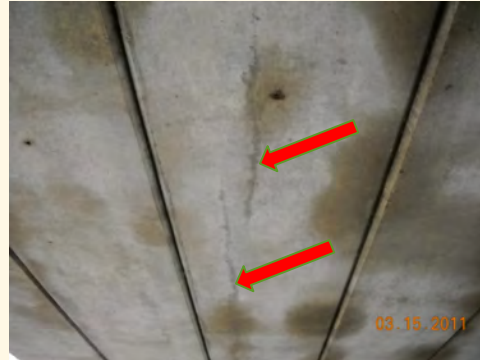
Prestressing strands adjacent to longitudinal cracks shall be considered as ineffective

The "end quarters of span" do not include the beam ends (last 3')

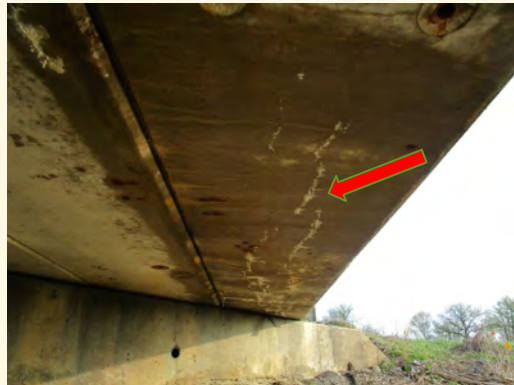
Prestressing strands adjacent to longitudinal cracks shall be considered as ineffective

Note keyway leaking full length of beam

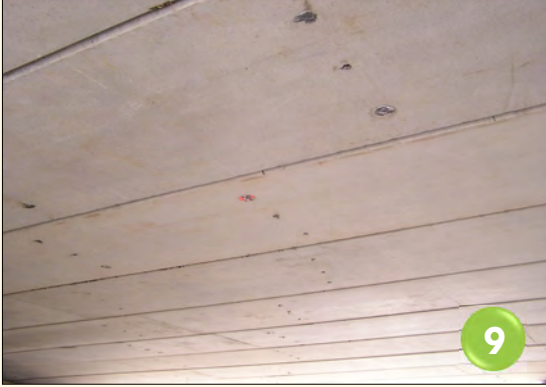
**New Construction**

**No deficiencies**

**New Deck Beam – Allowed first inspection only**

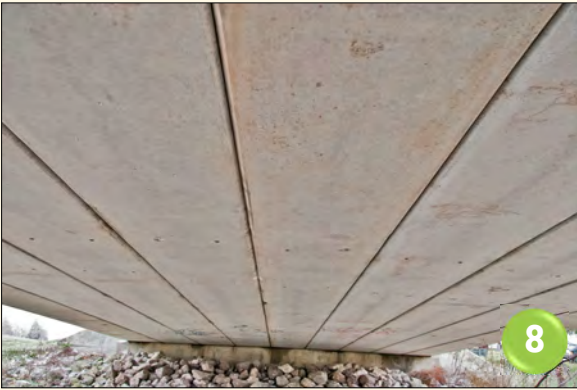
**Very Good Condition**

- No Deficiencies
- Not 1<sup>st</sup> inspection

**VERY GOOD. No notable problems.**

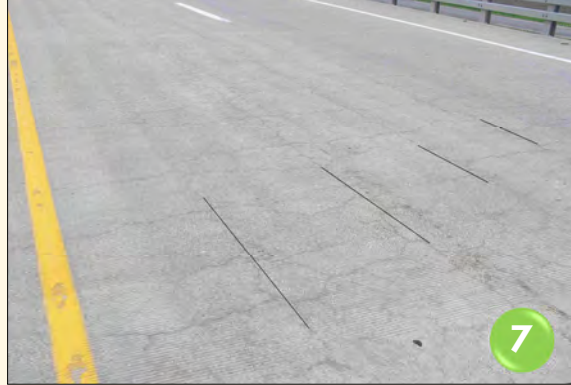
### Good Condition

- Cracks in the RC overlay (0.02")
- No noticeable keyway leakage
- Rigid wearing surface would be rated as the Deck (Item 58)
- Deck would be rated "4" due to widespread map cracking.
- Item 59 is a "7"

GOOD. No beams with prestressing strands, stirrup reinforcement bars or wire mesh exposed. **Moderate cracking** and leakage **may be present in keyways**, but no differential movement occurring between deck beams.

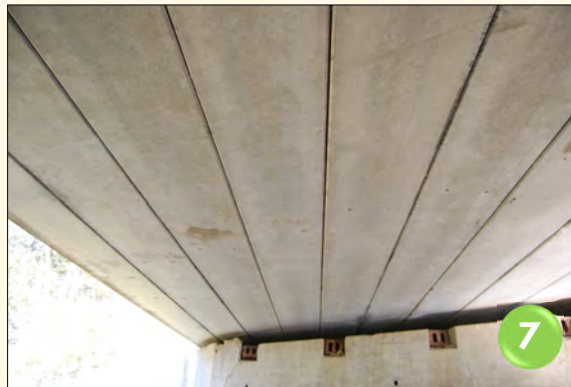
### Good Condition

- Underside of the Superstructure in the previous slide
- Reflective cracking in the rigid WS may indicate cracked or failed keyways

GOOD. No beams with prestressing strands, stirrup reinforcement bars or wire mesh exposed. **Moderate cracking** and leakage **may be present in keyways**, but no differential movement occurring between deck beams.

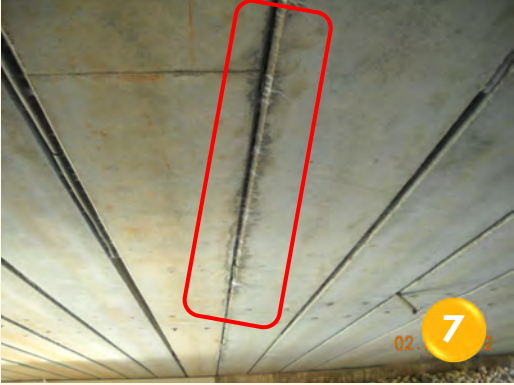
**Good Condition**

- Moderate keyway leakage with efflorescence
- Beams are still acting together

**GOOD.** No beams with prestressing strands, stirrup reinforcement bars or wire mesh exposed. **Moderate cracking and leakage may be present in keyways, but no differential movement occurring between deck beams.**

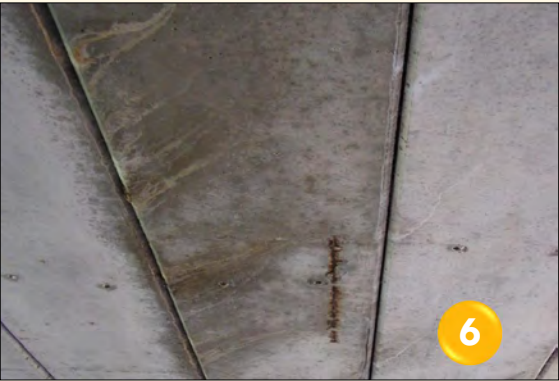
**Satisfactory Condition**

- Keyway leakage
- Beams still acting together
- Inadequate concrete cover has exposed mesh on one beam
- Verify exposed wire is not a prestress strand

**SATISFACTORY.** Center half of span: No beams with prestressing strands, stirrup reinforcement or wire mesh bars exposed, no longitudinal cracking reinforcement or wire mesh bars exposed, no longitudinal cracking or spalling along the bottom of the beams. End quarters of span: No more than **2 strands or 3" of stirrup reinforcement bars or 3" of wire mesh exposed in the bottom of any beam.** Larger widths of **wire mesh may be exposed** due to inadequate concrete cover occurring during manufacturing (up to 1/2" cover), **keyway cracking** may be evident with **wide spread leakage**, but beams are still fully acting together.

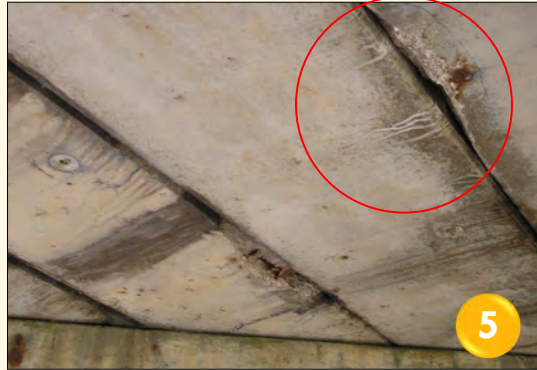
### Fair Condition

- Spall up to 6" wide in the end quarter of the span with reinforcement exposed
- Spall with reinforcement exposed near the beam end

FAIR. Center half of span: No more than 2 strands or 3" of stirrup reinforcement bars or 3" of wire mesh exposed in any beam, longitudinal cracking or spalling limited to one edge with no other defects exposing reinforcement, wire mesh or strands. End quarters of span: No more than 4 strands or 6" of stirrup reinforcement bars or 6" of wire mesh exposed in the bottom of any beam, no more than one longitudinal crack in any beam without any other defect. Beam ends (up to 3'): Prestressed strands, stirrup reinforcement bars or wire mesh exposed up to full width of any beam bottom. Larger widths of wire mesh may be exposed due to inadequate concrete cover occurring during manufacturing (up to 1/2" cover), keyway cracking with extensive leakage and evidence that beams are beginning to act independently of each other.

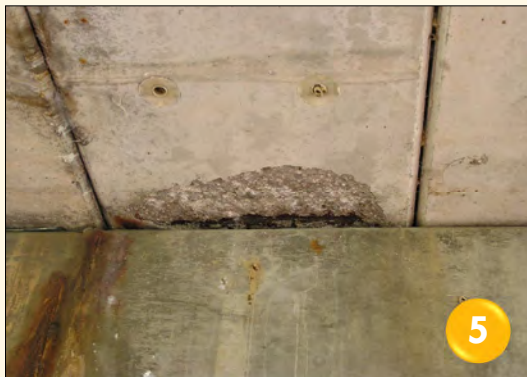
### Fair Condition

- Spall full width on the beam end with reinforcement exposed
- No other defects

FAIR. Center half of span: No more than 2 strands or 3" of stirrup reinforcement bars or 3" of wire mesh exposed in any beam, longitudinal cracking or spalling limited to one edge with no other defects exposing reinforcement, wire mesh or strands. End quarters of span: No more than 4 strands or 6" of stirrup reinforcement bars or 6" of wire mesh exposed in the bottom of any beam, no more than one longitudinal crack in any beam without any other defect. Beam ends (up to 3'): Prestressed strands, stirrup reinforcement bars or wire mesh exposed up to full width of any beam bottom. Larger widths of wire mesh may be exposed due to inadequate concrete cover occurring during manufacturing (up to 1/2" cover), keyway cracking with extensive leakage and evidence that beams are beginning to act independently of each other.

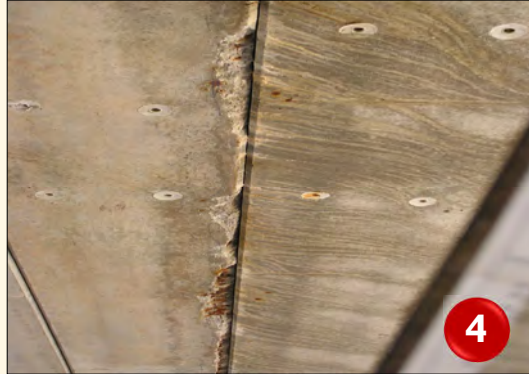
### Poor Condition

- Spalls with reinforcement exposed
- Width is 8" of the 36" beam width (less than 1/3 of the beam width)
- Location of defect is near center half of span

POOR. Center half of span: Prestressed strands, stirrup reinforcement bars or wire mesh exposed for no more than 1/2 the width of any beam bottom, spalling or delamination of the top of the beams down to the top reinforcement, one longitudinal crack in the bottom of any beam. End quarters of span: Prestressed strands, stirrup reinforcement bars or wire mesh exposed for no more than 1/2 the width of any beam bottom, two longitudinal cracks in the bottom of any beam. Beam ends (up to 3'): Prestressed strands, stirrup reinforcement bars or wire mesh exposed up to full width of adjacent beam bottom with no exposed strands in the second layer of strands and sound concrete above the bottom layer. Larger width of wire mesh exposed and actively corroding due to inadequate concrete cover occurring during manufacturing (up to 1/2" cover), keyway has failed with groups of beams acting independently of others.

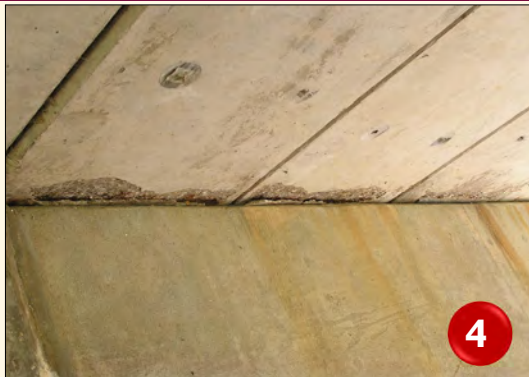
### Poor Condition

- Spalls with reinforcement exposed
- Full width of adjacent beam ends

POOR. Center half of span: Prestressed strands, stirrup reinforcement bars or wire mesh exposed for no more than 1/2 the width of any beam bottom, spalling or delamination of the top of the beams down to the top reinforcement, one longitudinal crack in the bottom of any beam. End quarters of span: Prestressed strands, stirrup reinforcement bars or wire mesh exposed for no more than 1/2 the width of any beam bottom, two longitudinal cracks in the bottom of any beam. Beam ends (up to 3'): Prestressed strands, stirrup reinforcement bars or wire mesh exposed up to full width of adjacent beam bottom with no exposed strands in the second layer of strands and sound concrete above the bottom layer. Larger width of wire mesh exposed and actively corroding due to inadequate concrete cover occurring during manufacturing (up to 1/2" cover), keyway has failed with groups of beams acting independently of others.

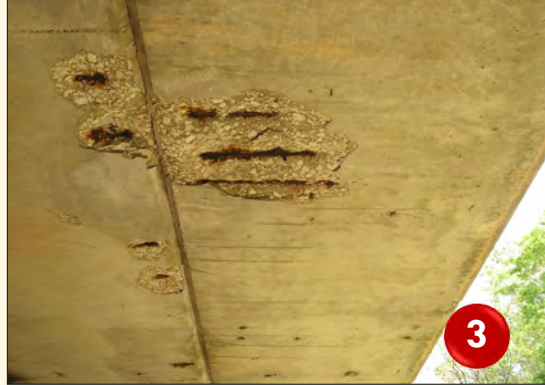
### Serious Condition

- Spalls or delaminations
- Width is 15" of 36" beam width ( $> 1/3 < 1/2$  of width)
- Location of defect is in center half span

SERIOUS. Center half of span: **Prestressing strands, stirrup reinforcement bars or wire mesh exposed** for no more than  $1/2$  the width of any beam bottom, two longitudinal cracks in the bottom of any beam, combinations of deterioration in condition rating "4". End quarters of span: Prestressing strands, stirrup reinforcement bars or wire mesh exposed for no more than  $1/2$  the width of any beam bottom, combination of deterioration in condition rating "4". Beam ends (up to 3'): Prestressed strands, stirrup reinforcement bars or wire mesh exposed full width of adjacent beam bottom with exposed strands in the second layer of strands or unsound concrete above the bottom layer. Keyways have failed causing 3 or 4 beams to act independently from others.

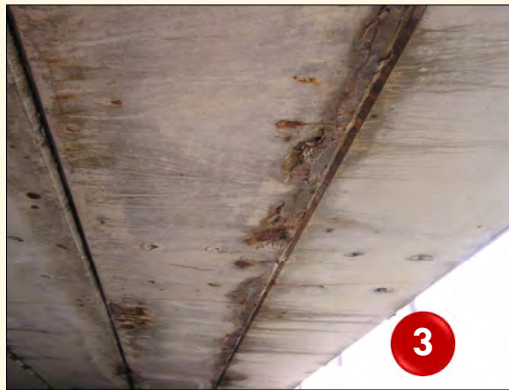
### Serious Condition

- Spalls or delaminations
- Width is 14" (8" + 6") of the 36" beam width ( $> 1/3 < 1/2$  of width)
- Located in center half of span
- Keyway failure indicated by observed differential movement

SERIOUS. Center half of span: **Prestressing strands, stirrup reinforcement bars or wire mesh exposed** for no more than  $1/2$  the width of any beam bottom, two longitudinal cracks in the bottom of any beam, combinations of deterioration in condition rating "4". End quarters of span: Prestressing strands, stirrup reinforcement bars or wire mesh exposed for no more than  $1/2$  the width of any beam bottom, combination of deterioration in condition rating "4". Beam ends (up to 3'): Prestressed strands, stirrup reinforcement bars or wire mesh exposed full width of adjacent beam bottom with exposed strands in the second layer of strands or unsound concrete above the bottom layer. **Keyways have failed** causing 3 or 4 beams to act independently from others.

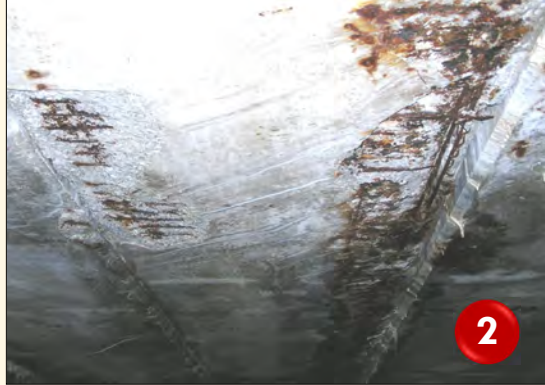
KD-31

### Critical Condition

- Spalls or delaminations
- Combined width is 26" of the 36" beam width (> 1/2 of width)
- Several keyways have failed with observed differential movement

**CRITICAL.** Similar to but more serious and extensive than what is described for a condition rating of "3", transverse cracks full width in the bottom of the beams, **keyways have failed causing 1 or 2 beams to act independently** from others. Structural elements that are judged to be in critical condition must receive special inspections in order for the structure to remain open to traffic. **The Bureau of Bridges and Structures shall be notified immediately.**

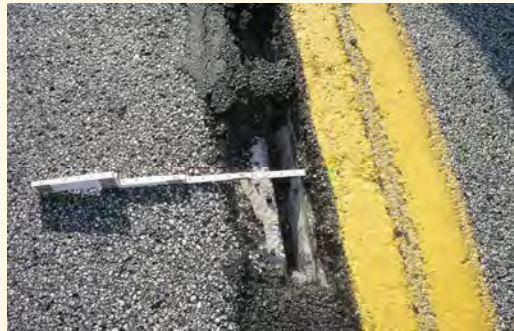
KD-32

## Item 59 - PPC Deck Beams

- Example of beams acting independently due to keyway failure
- Bituminous overlay becomes dislodged by differential movement of beams

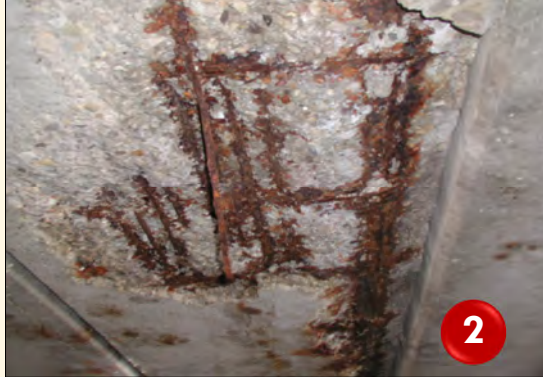
KD-33

### Critical Condition

- Spalls or delaminations
- Width extends 34" across the 36" beam width ( $> \frac{1}{2}$  width)
- Exposed prestressed strands
- Keyway failure
- Notify BBS immediately

**CRITICAL.** Similar to but more serious and extensive than what is described for a condition rating of "3", transverse cracks full width in the bottom of the beams, **keyways have failed** causing 1 or 2 beams to act independently from others. Structural elements that are judged to be in critical condition must receive special inspections in order for the structure to remain open to traffic. **The Bureau of Bridges and Structures shall be notified immediately.**

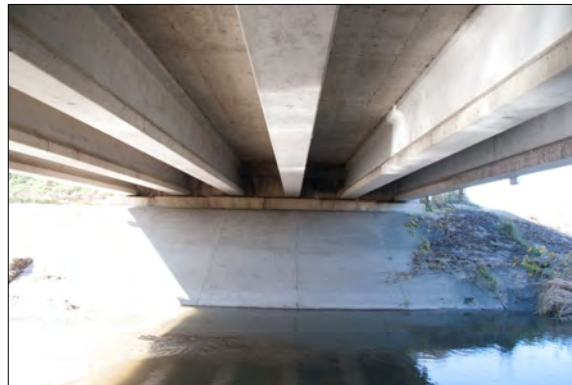
KI-4

### Sounding

- Use hammer sounding to detect delaminated areas
- Delaminations have a distinctive “hollow or clacking” sound
- Sound concrete has a solid “pinging” sound

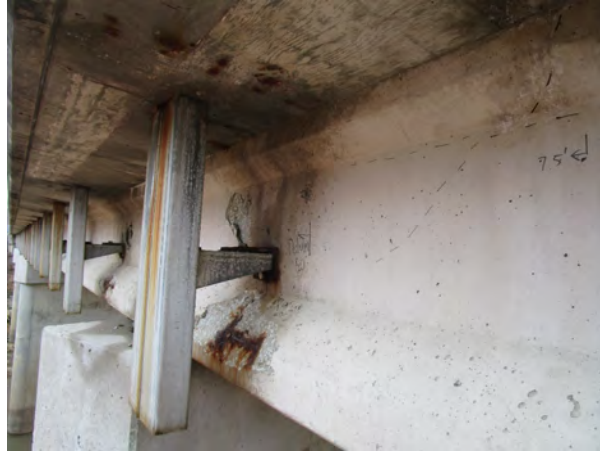
KI-5

### Delams, Spalls & Strikes

#### Look Around:

- Current & old deck drain locations
- Beneath transverse deck joints
- Adjacent to current or old longitudinal deck joints
- Above traffic lanes

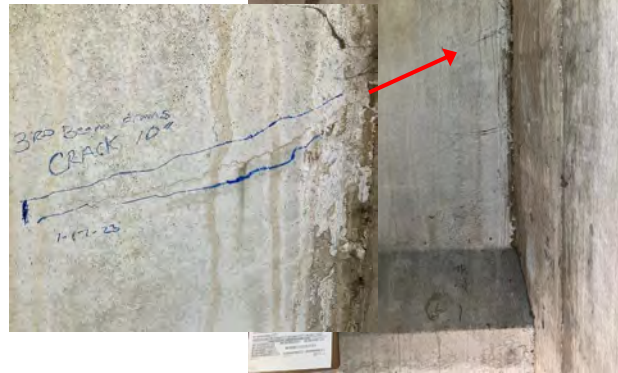
KI-6

### Shrinkage Cracks

### For Shrinkage Cracks

- Beam ends
- Look for tight cracks starting from the beam ends
- Moderate amounts = 7 rating

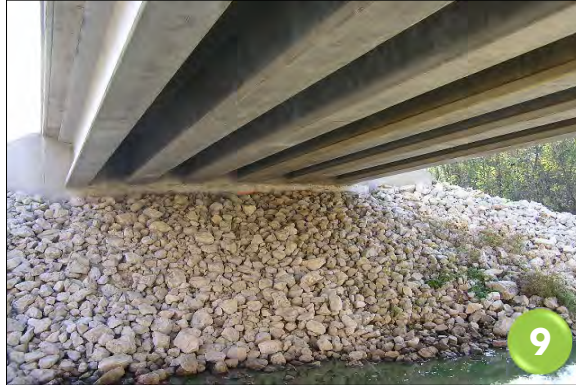
KI-13

### New Construction

- No defects
- First inspection

New PPC I-Beam – Allowed first inspection only

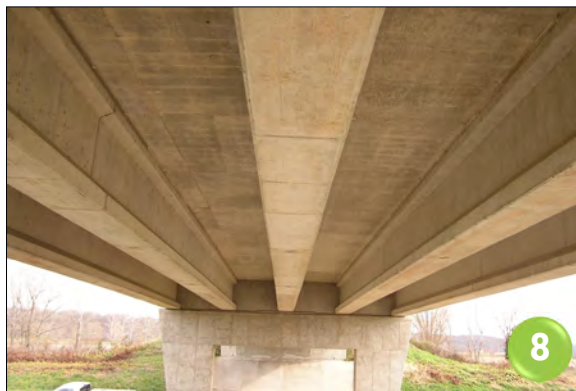
KI-14

### Very Good

- No deficiencies
- Second inspection

VERY GOOD. No notable problems.

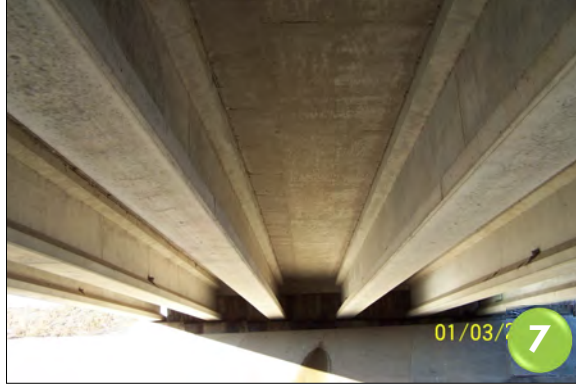
KI-15

**Good**

Minor shrinkage cracks present in beams

**GOOD.** No beams with prestressing strands, stirrup reinforcement bars or wire mesh exposed. **Minor shrinkage** or release **cracks** may be present. Minor map cracking at drains with sound concrete.

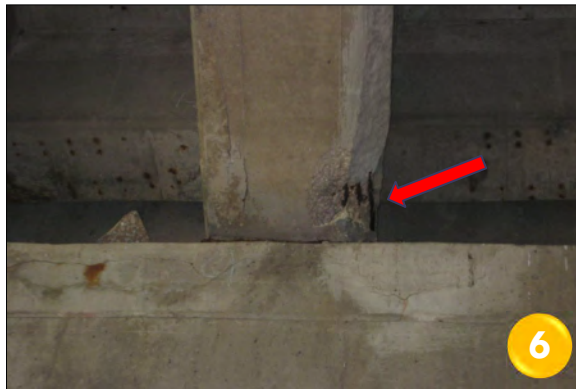
KI-16

**Satisfactory**

Three strands exposed at the end of the beam

**SATISFACTORY.** Center half of span: No beams with prestressing strands, stirrup reinforcement exposed. End quarters of span: No more than 2 strands or 3" of stirrup reinforcement bars exposed in the bottom of any beam. Beam ends (up to 3'): **Prestressed strands or stirrup reinforcement bars exposed** up to 1/2 the perimeter of the bottom flange of any beam. Larger width of stirrups may be exposed due to inadequate concrete cover occurring during manufacturing (up to 1/2 cover). Webs may be spalled with exposed stirrups and only surface rust.

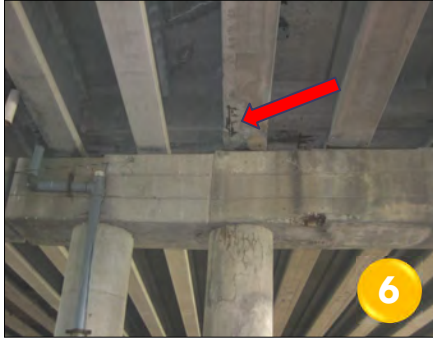
Two strands of reinforcement bars exposed in the bottom of beam

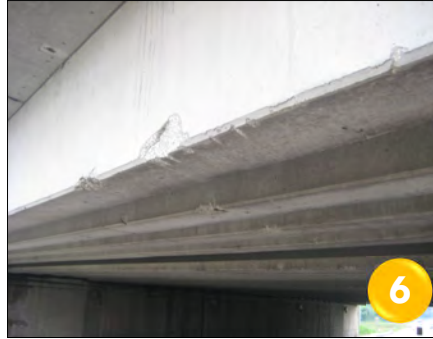
No beams with reinforcement exposed at center span

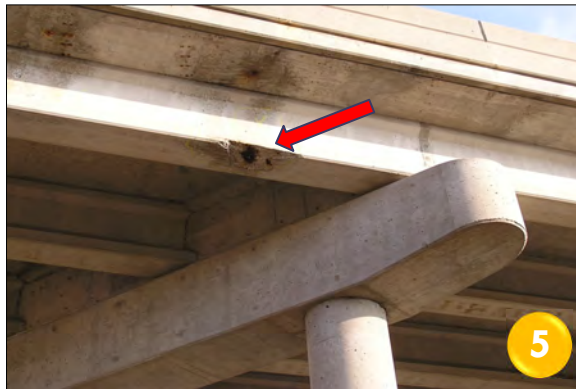
#### Fair

Reinforcement bars exposed for 30% of perimeter of bottom flange in end quarter of span

FAIR. Center half of span: Prestressed strands or stirrup reinforcement bars exposed for no more than 1/4 the perimeter of the bottom flange of any beam. End quarters of span: Prestressed strands or stirrup reinforcement bars exposed for no more than 1/3 the perimeter of the bottom flange of any beam. Beam ends (up to 3'): Prestressed strands or stirrup reinforcement bars exposed from 1/2 to full perimeter of the bottom flange of any beam. Larger areas of stirrup may be exposed due to inadequate concrete cover that occurs during manufacturing (up to 1/2 cover). Webs may be spalled with exposed stirrups minor section loss.

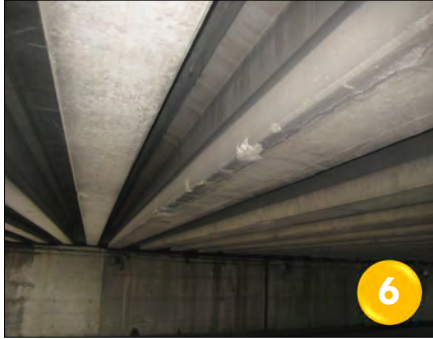
6

No beams with reinforcement exposed at center span

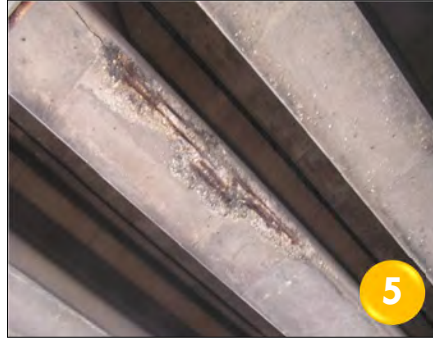
5

Spall with 4 exposed strands in the end quarter

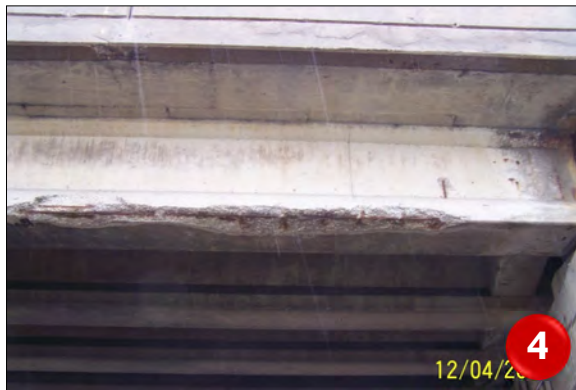
#### Poor

Reinforcement bars exposed for more than 55% of perimeter of bottom flange in end quarter

POOR. Center half of span: Prestressed strands or stirrup reinforcement bars exposed for no more than 2/3 the perimeter of the bottom flange of any beam. End quarters of span: **Prestressed strands or stirrup reinforcement bars exposed** up to full perimeter of the bottom flange of any beam. No strands are exposed inside the exterior perimeter of strands. Beam ends (up to 3'): Prestressed strands or stirrup reinforcement bars exposed full perimeter of the bottom flange of any beam with some strands exposed inside the exterior perimeter of strands. Webs are spalled with exposed stirrups with up to 30% section loss at ends of beams.

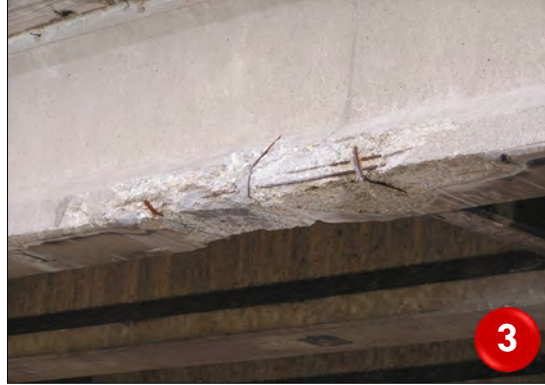
KI-21

### Serious

Strands exposed for full perimeter of bottom flange in center half of span

**SERIOUS.** Center half of span: Prestressed strands or stirrup reinforcement bars exposed up to full perimeter of the bottom flange of any beam. No strands are exposed inside the exterior perimeter of strands. End quarters of span: Prestressing strands, stirrup reinforcement bars exposed for the full perimeter of the bottom flange of any beam with some strands exposed inside the exterior perimeter of strands. Hairline transverse cracks in bottom of beams or hairline vertical/diagonal shear cracks in beam webs may be developing

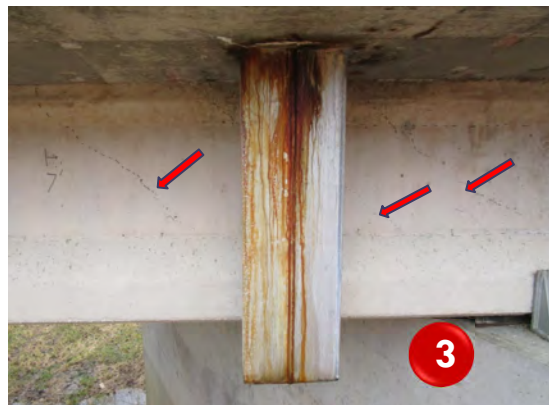
KI-22

### Serious

Tight diagonal shear cracks in beam web at the beam end quarter & beam end.

**SERIOUS.** Center half of span: Prestressed strands or stirrup reinforcement bars exposed up to full perimeter of the bottom flange of any beam. No strands are exposed inside the exterior perimeter of strands. End quarters of span: Prestressing strands, stirrup reinforcement bars exposed for the full perimeter of the bottom flange of any beam with some strands exposed inside the exterior perimeter of strands. Hairline transverse cracks in bottom of beams or hairline vertical/diagonal shear cracks in beam webs may be developing

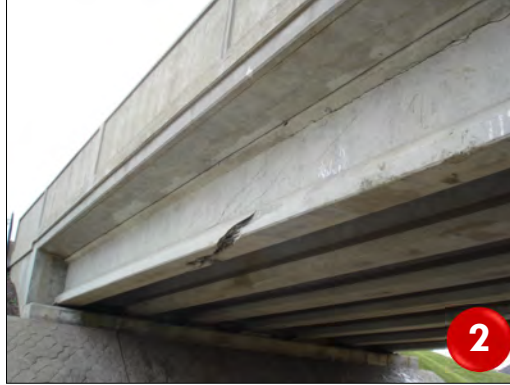
KI-23

### Critical

- Prestressing strands exposed over full perimeter
- Open shear cracks
- Damage in middle half of beam

**CRITICAL.** Similar to but **more serious and extensive** than what is described for a condition rating of "3". Structural elements that are judged to be in critical condition must receive special inspections in order for the structure to remain open to traffic. **Measurable shear or transverse cracks.** The Bureau of Bridges and Structures shall be notified immediately.

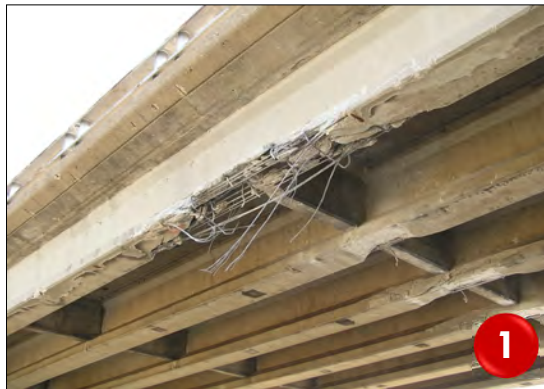
KI-24

### Imminent Failure

- Exterior beam has failed
- Strands exposed for full perimeter of bottom flange at center span

**IMMINENT FAILURE.** **Condition requiring bridge closure or temporary measures** to allow structure to remain open

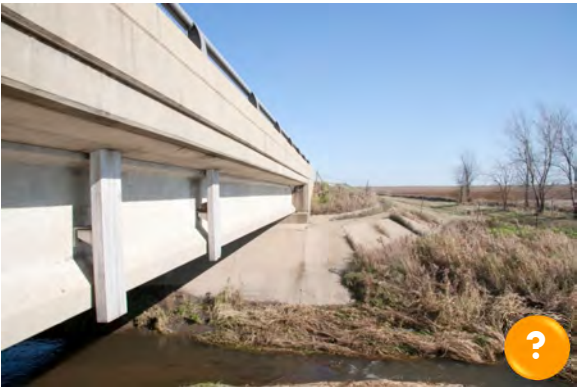
KI-26

**KI-1: How would you rate this Superstructure?**  
Minor shrinkage cracks present

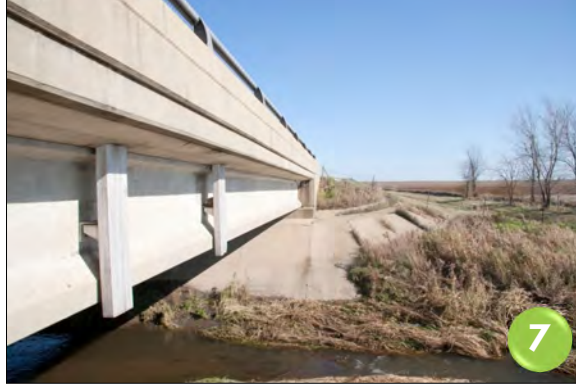
KI-27

**Good**

**Minor shrinkage cracks present**

**GOOD.** No beams with prestressing strands, stirrup reinforcement bars or wire mesh exposed. **Minor shrinkage or release cracks may be present.** Minor map cracking at drains with sound concrete.

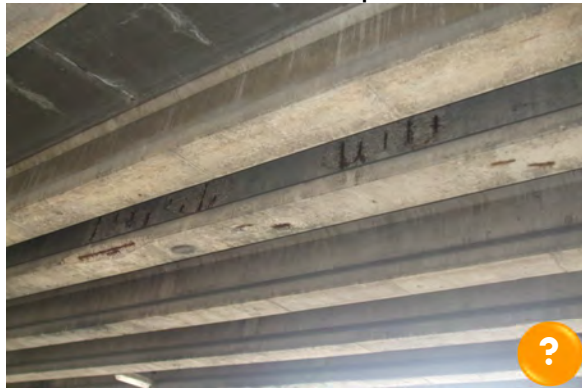
KI-28

Reinforcement bars exposed for 22% of the perimeter of the bottom flange in the center half. The web is spalled with minor section loss to the stirrups.

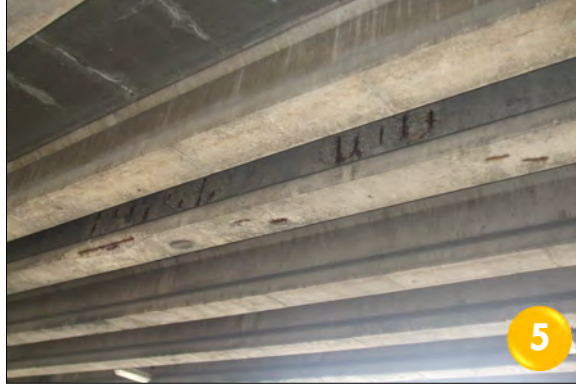
KI-29

Reinforcement bars exposed for 22% of perimeter of bottom flange in center half.

The web is spalled with minor section loss to stirrups.

**FAIR.** Center half of span: Prestressed strands or stirrup reinforcement bars exposed for no more than ¼ of the perimeter of the bottom flange of any beam. End quarters of span: Prestressed strands or stirrup reinforcement bars exposed for no more than 1/3 the perimeter of the bottom flange of any beam. Beam ends (up to 3'): Prestressed strands or stirrup reinforcement bars exposed from ¼ to full perimeter of the bottom flange of any beam. Larger areas of stirrup may be exposed due to inadequate concrete cover that occurs during manufacturing (up to ½ cover). Webs may be spalled with exposed stirrups minor section loss.

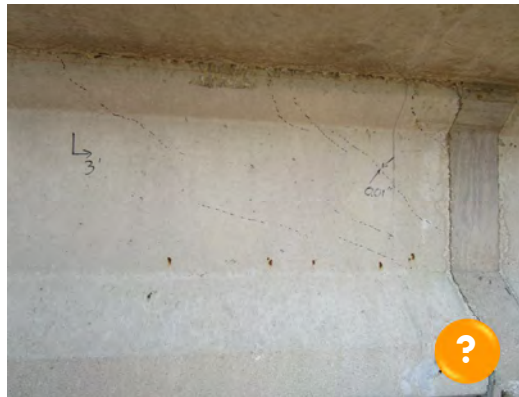
KI-30

Tight diagonal cracks are found in the beam webs near the beam ends.

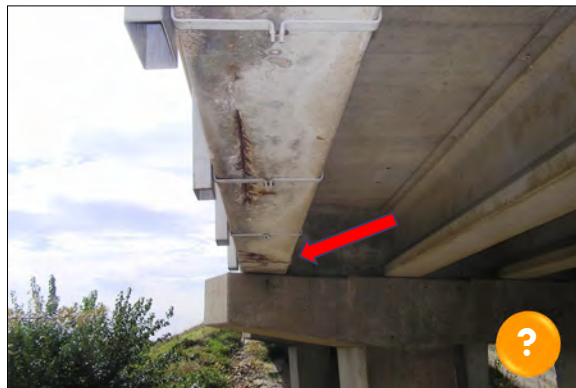
KI-32

Reinforcement bars exposed for 58% of the perimeter of the bottom flange at center half of span

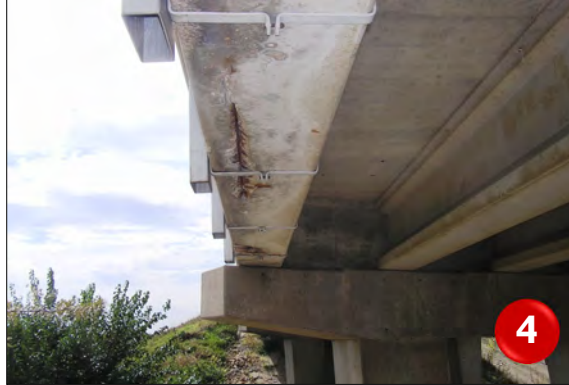
KI-33

### Poor

Reinforcement bars exposed for 58% of perimeter of bottom flange at center span

POOR. Center half of span: Prestressed strands or stirrup reinforcement bars exposed for no more than 2/3 the perimeter of the bottom flange of any beam. End quarters of span: Prestressed strands or stirrup reinforcement bars exposed up to full perimeter of the bottom flange of any beam. No strands are exposed inside the exterior perimeter of strands. Beam ends (up to 3'): Prestressed strands or stirrup reinforcement bars exposed full perimeter of the bottom flange of any beam with some strands exposed inside the exterior perimeter of strands. Webs are spalled with exposed stirrups with up to 30% section loss at ends of beams.

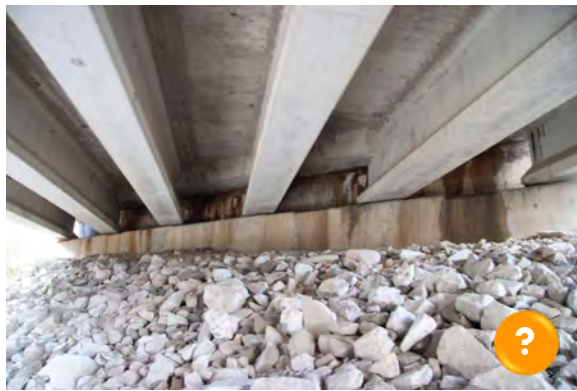
KI-34

Shrinkage Cracks with no reinforcement exposed

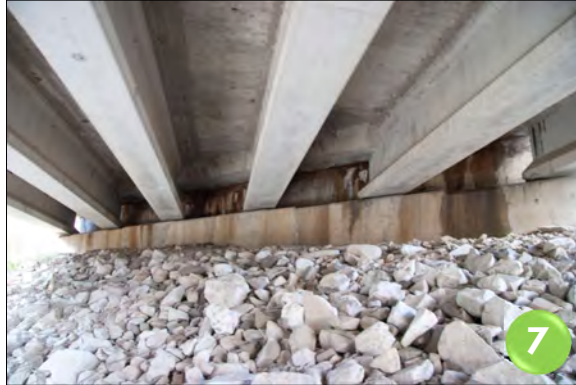
KI-35

**Good**

Shrinkage cracks with no reinforcement exposed

**GOOD.** No beams with prestressing strands, stirrup reinforcement bars or wire mesh exposed. **Minor shrinkage** or release **cracks** may be present. Minor map cracking at drains with sound concrete.

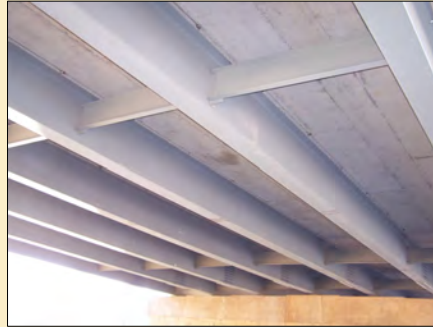
I-3

#### Rolled I-Beams

- Various standard sizes:
  - 18" – 36" depths common in bridges (3" increments)
  - 40" & 44" also available
- May have bearing stiffeners
- Common in short to mid span steel bridges

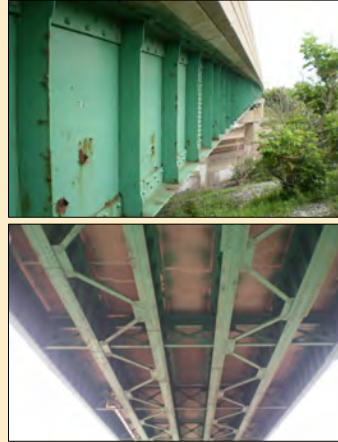
I-5

#### Riveted Girder (I-shape)

- ▣ Made up of plates and angles riveted together
- ▣ Width and thickness of flanges and webs can be varied
- ▣ Usually have bearing stiffeners
- ▣ Often have intermediate stiffeners

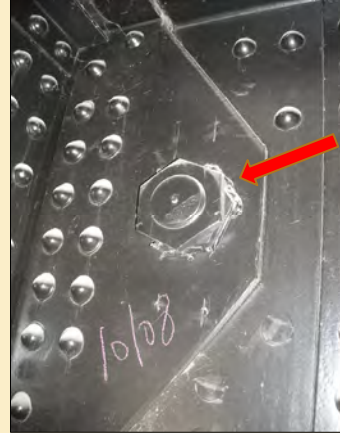
I-11

#### Pin Connection

Single pin used without hanger bars to allow rotation only

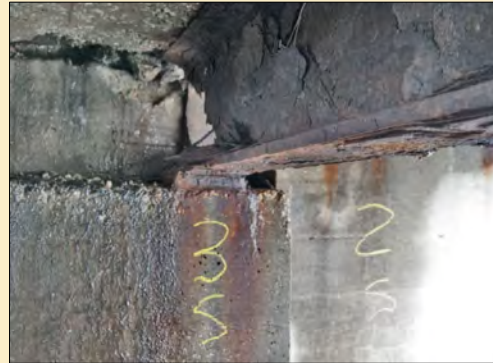
I-13

### Common Missed Deficiencies

- Section loss at beam ends below transverse deck joints
- Look for heavy section loss in webs and in the bearing area
- For **ratings  $\leq 3$**  due to web section loss at the bearing area PM's are responsible for **installing/recommending wood blocking** between flanges to resist web crushing (July 2017)

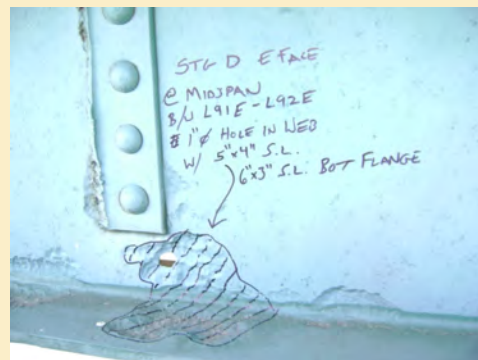
I-14

### Common Missed Deficiencies

- Section loss along the bottom of the web and
- Section loss along the top of the bottom flange
- Section loss around diaphragm connections

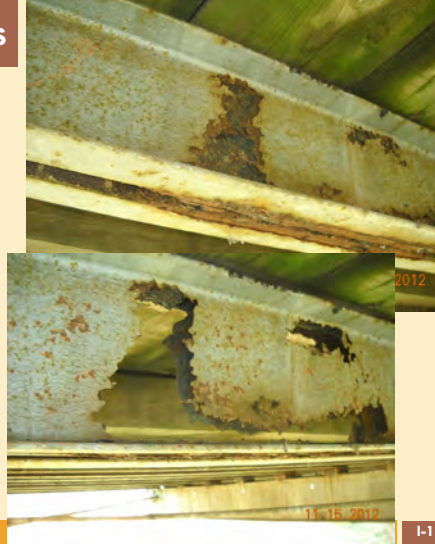
#### Defects Hidden by Pack Rust

- ❑ Superstructure rating had just been lowered from a 5 to a 4
- ❑ The condition of the floor stringers was not considered in the rating
- ❑ Actual super rating was a 1 !!

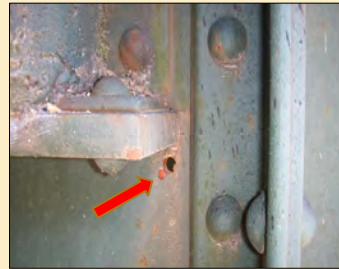
### Cracks at Connections

Cracks can occur at rigid connections of transverse members to thin webs due to out-of-plane bending

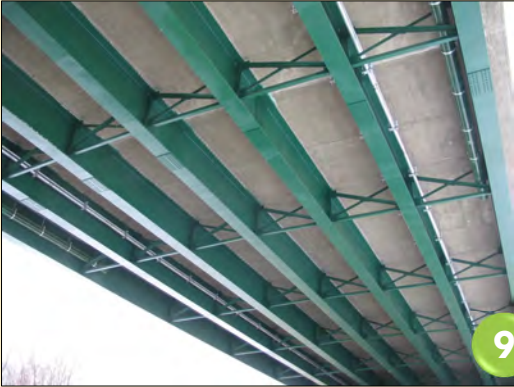
### New Construction

No deficiencies

New superstructure – Allowed first inspection only

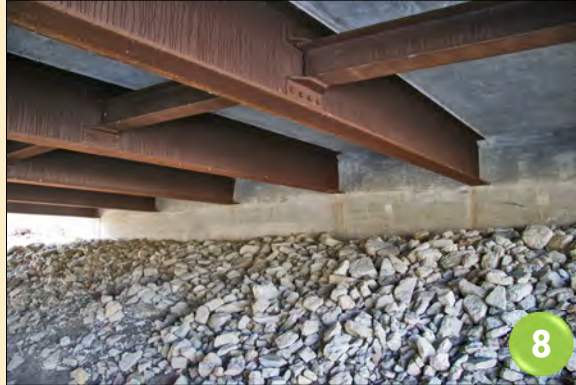
### Very Good Condition

- No deficiencies
- Not new construction
- Note: Weathering Steel**

VERY GOOD. No "excessive" rust.

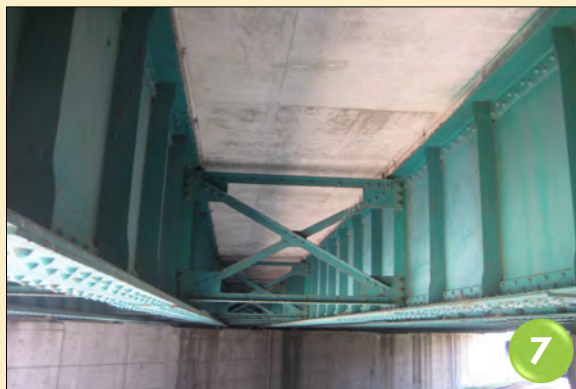
### Good Condition

- Minor rust on the bottom flanges
- No section loss

GOOD. **Some rust** may be present but **without any section loss**.

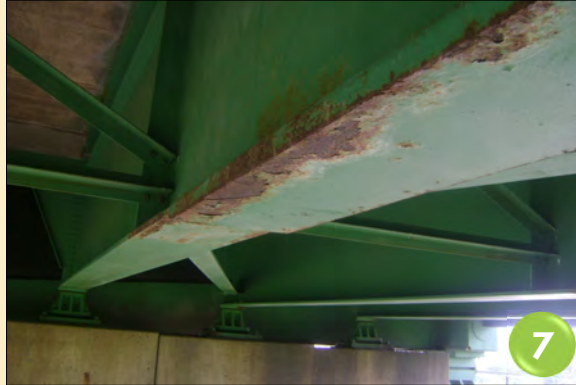
### Good Condition

- Minor rust on bottom flange
- No section loss

**GOOD.** Some rust may be present but **without any section loss.**
