# TIMBER SUPERSTRUCTURES

IL NBI Refresher Course 2024

## Item 59 - Timber Superstructures

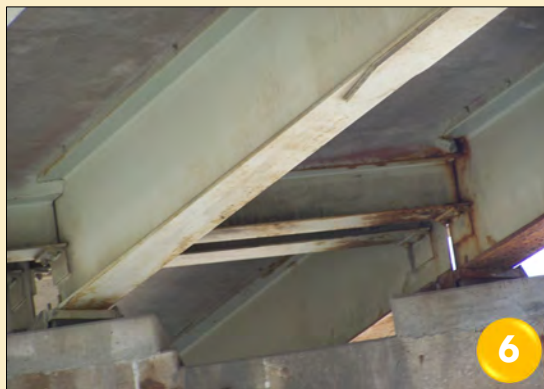
### Satisfactory Condition

- Initial section loss in non-critical area of bottom flange
- Rust stains on web resulting from rust on secondary member

**SATISFACTORY.** Initial section loss (minor pitting, scaling, or flaking) up to 2% section loss.

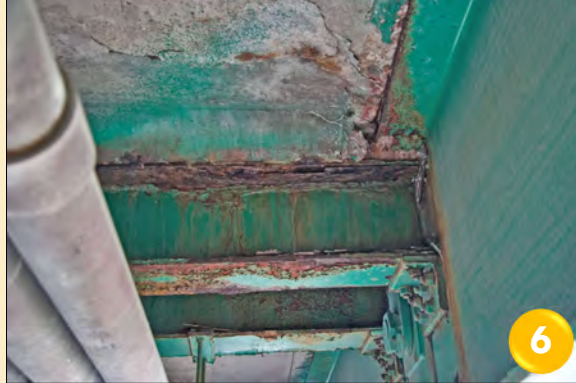
### Satisfactory Condition

- Section loss on flanges of diaphragm (secondary member)
- No section loss on girder web

**SATISFACTORY.** Initial **section loss** (minor pitting, scaling, or flaking) up to 2% section loss.

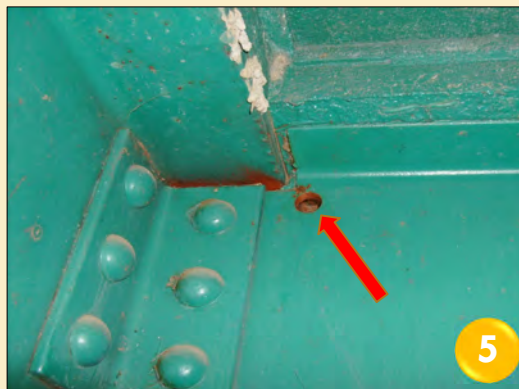
### Fair Condition

- Minor cracks
- Arrester holes have been drilled in web to prevent further progression of cracks

**FAIR.** Initial **section loss** up to 10% in critical areas, fatigue or **out-of-plane bending cracks** may be present in secondary members, arrested fatigue **cracks** may be present in primary members, hinges may be showing minor corrosion problems, anchor bolt(s) may be missing.

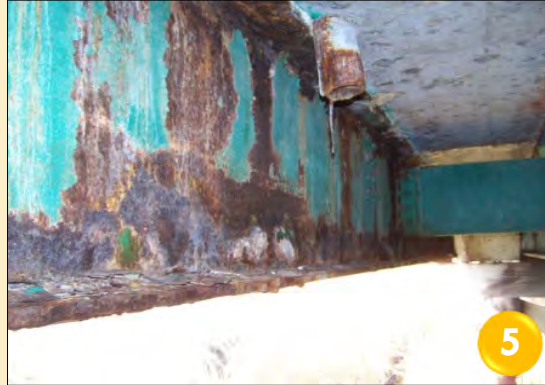
### Fair Condition

8% section loss at bottom flange and on web of girder

FAIR. Initial **section loss** up to 10% in critical areas, fatigue or out-of-plane bending cracks may be present in secondary members, arrested fatigue cracks may be present in primary members, hinges may be showing minor corrosion problems, anchor bolt(s) may be missing.

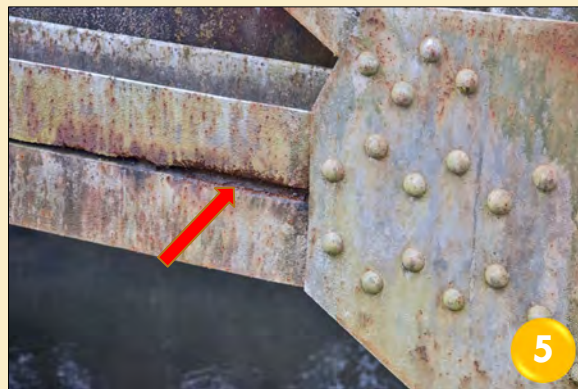
### Fair Condition

7% Section loss along the lateral edge bracing

FAIR. Initial **section loss** up to 10% in critical areas, fatigue or out-of-plane bending cracks may be present in secondary members, arrested fatigue cracks may be present in primary members, hinges may be showing minor corrosion problems, anchor bolt(s) may be missing.

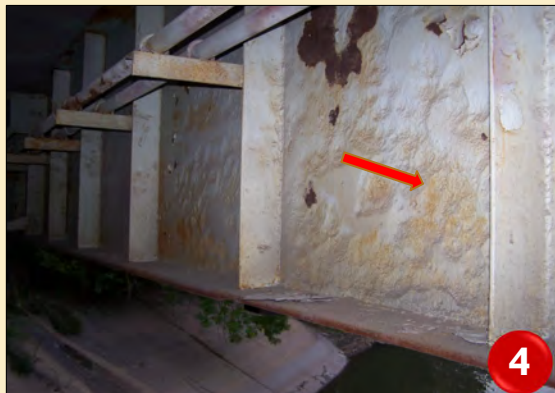
### Poor Condition

25% section loss  
in the web of the  
girder

**POOR.** Section loss up to 30% in critical area, fatigue or out-of-plane bending cracks may be present in primary members, previously arrested fatigue cracks propagating beyond arresting holes in primary members, fatigue cracks in secondary members throughout the bridge, anchor bolts or pintles broken on rocker bearings with an offset of  $\frac{1}{2}$ " or more between the rocker and the bearing or sole plates.

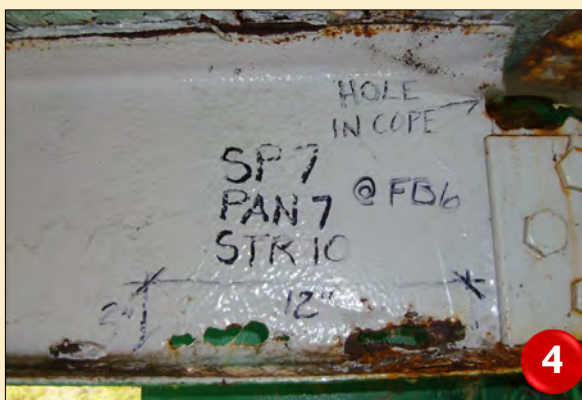
### Poor Condition

- 25% section loss in web
- Hole at cope

**POOR.** Section loss up to 30% in critical area, fatigue or out-of-plane bending cracks may be present in primary members, previously arrested fatigue cracks propagating beyond arresting holes in primary members, fatigue cracks in secondary members throughout the bridge, anchor bolts or pintles broken on rocker bearings with an offset of  $\frac{1}{2}$ " or more between the rocker and the bearing or sole plates.

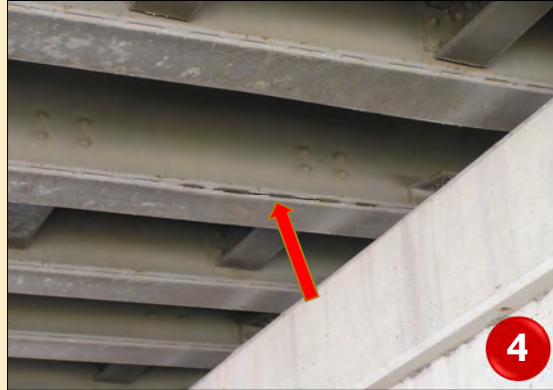
### Poor Condition

- Cracked intermittent welds along edge of cover plate
- (cover plate area = 28% of bottom flange)

POOR. **Section loss** up to 30% in critical area, fatigue or out-of-plane bending cracks may be present in primary members, previously arrested fatigue cracks propagating beyond arresting holes in primary members, fatigue cracks in secondary members throughout the bridge, anchor bolts or pintles broken on rocker bearings with an offset of  $\frac{1}{2}$ " or more between the rocker and the bearing or sole plates.

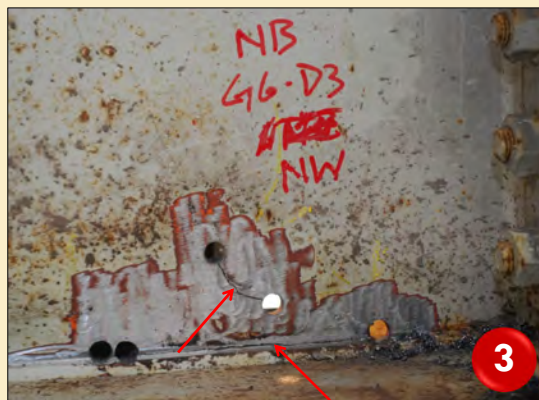
### Serious Condition

- Cracks in web along bottom flange
- Arrested crack perpendicular to stress in web
- 15% section loss in lower portion of web

SERIOUS. Advanced **section loss** up to 50%, extensive perpendicular to stress fatigue or out of plane bending **cracks** in primary members.

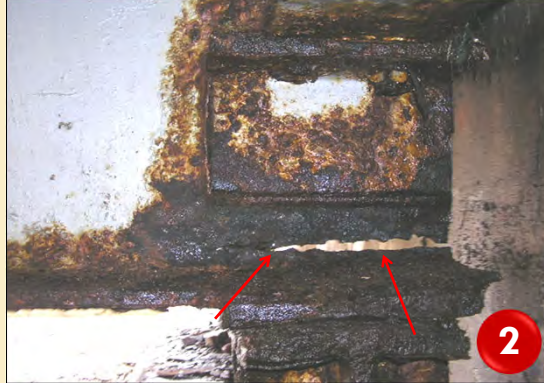
### Critical Condition

- 80% section loss above bearing
- Critical section for bearing at beam end is cut horizontally
- Critical section for shear near beam end is cut vertically

**CRITICAL.** Severe **section loss** over 50% requires special inspections, temporary supports or repairs may be required to remain open to traffic. The Bureau of Bridges and Structures shall be notified immediately. (**install wood blocking**)

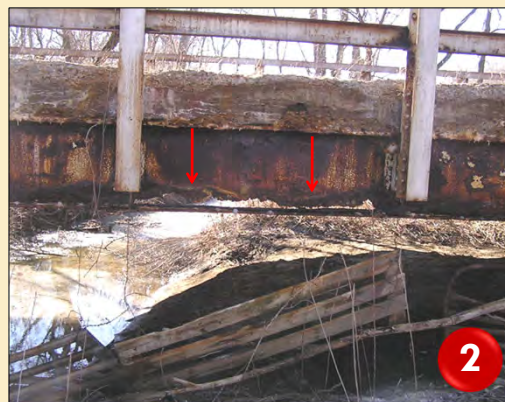
### Critical Condition

- 50% section loss of web at mid-span
- 100% section loss of bottom flange at mid-span (completely disconnected from web)

**CRITICAL.** Severe **section loss** over 50% requires special inspections, temporary supports or repairs may be required to remain open to traffic. The Bureau of Bridges and Structures shall be notified immediately.

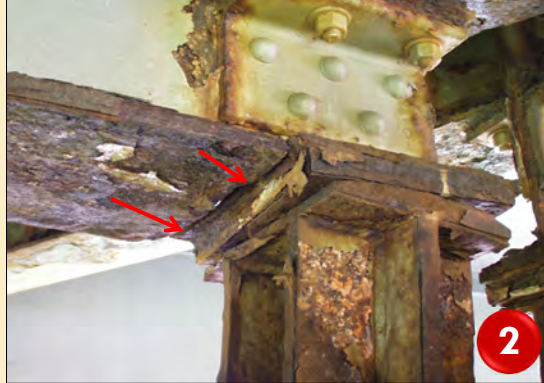
### Critical Condition

Bottom flange cracked at bearing

**CRITICAL.** Severe **section loss** over 50% requires special inspections, temporary supports or repairs may be required to remain open to traffic. The Bureau of Bridges and Structures shall be notified immediately.

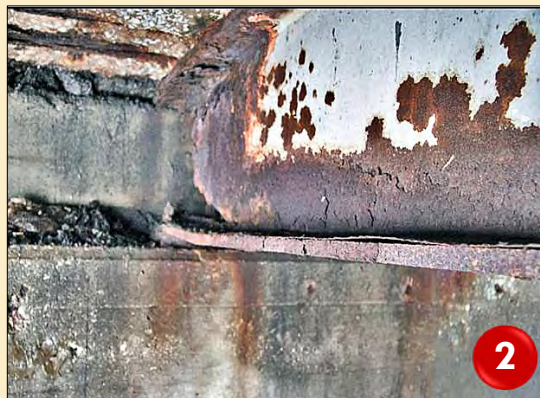
### Critical Condition

- ❑ Severe section loss throughout
- ❑ 100% section loss above bearing
- ❑ Beam supported by bottom flange in flexure

**CRITICAL.** Severe **section loss** over 50% requires special inspections, temporary supports or repairs may be required to remain open to traffic. The Bureau of Bridges and Structures shall be notified immediately. (**install wood blocking**)

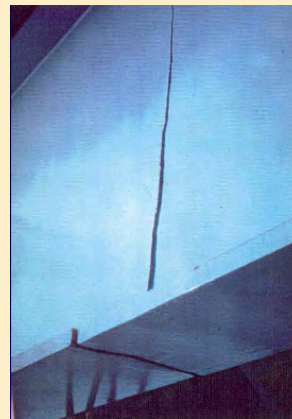
The separation of a member into two parts.

Fractured Girder

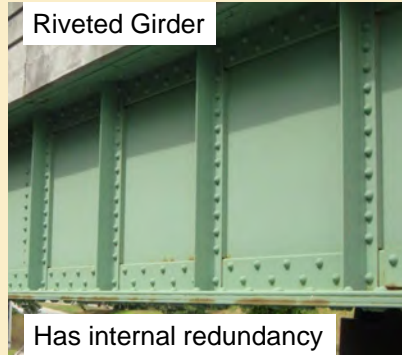
**Internal Redundancy** – a member configuration containing 3 or more elements mechanically fastened together (by rivets or bolts) to form multiple independent load paths

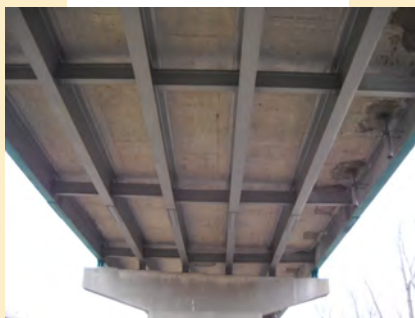
**Load Path Redundancy** – having 3 or more main load carrying members between substructure units

Load Path Redundant

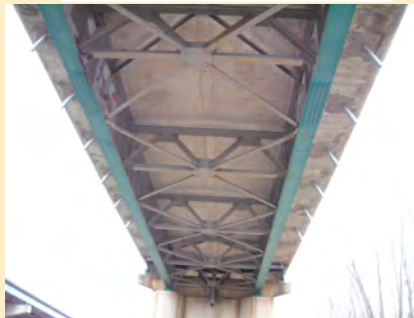
Not Load Path Redundant

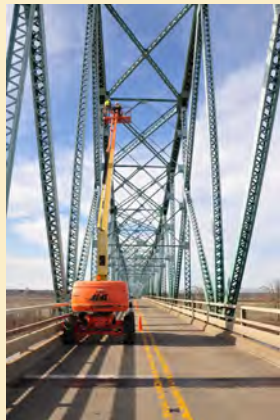
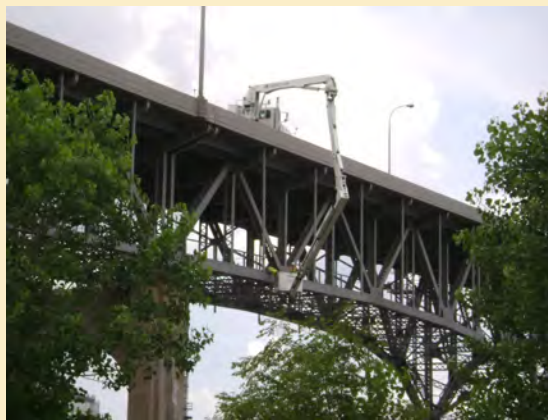
Equipment Needs (Access Equip. – **Arms Length Reach**):

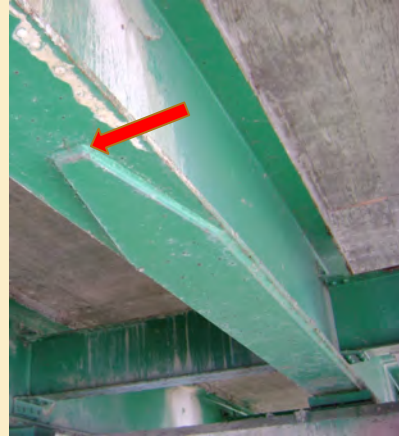
### Where to Look – Sudden Change in Cross Section:

- Sudden changes in cross section cause stress increases
  - Cover plate terminations
  - Changes in plate size
- These are susceptible locations for fatigue cracks to initiate

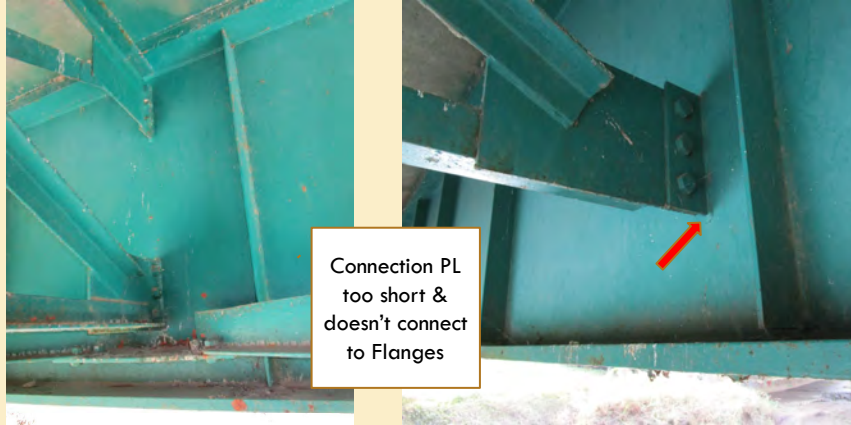
I-21

### Where to Look – Cross Frames

**POOR** Cross Frame connection details – look at ends of plates in tension zones of girders

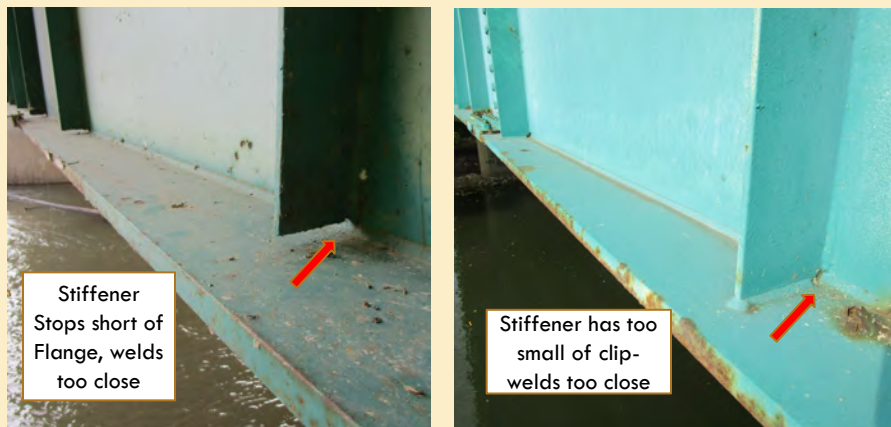
I-22

### Where to Look – Transverse Web Stiffeners/Cross Frames

**POOR** Web Stiffener connection details – look at ends of plates in tension zones of girders

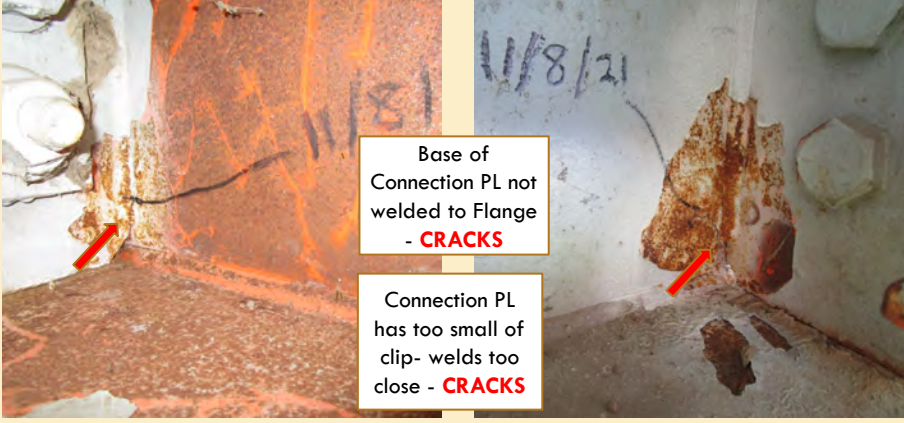
#### Where to Look – Cross Frames & Diaphragms

Base of Connection PL not welded to Flange - **CRACKS**

Connection PL has too small of clip- welds too close - **CRACKS**

**POOR** Cross Frame/Diaphragm connection details – cracks at ends of PL in tension zones

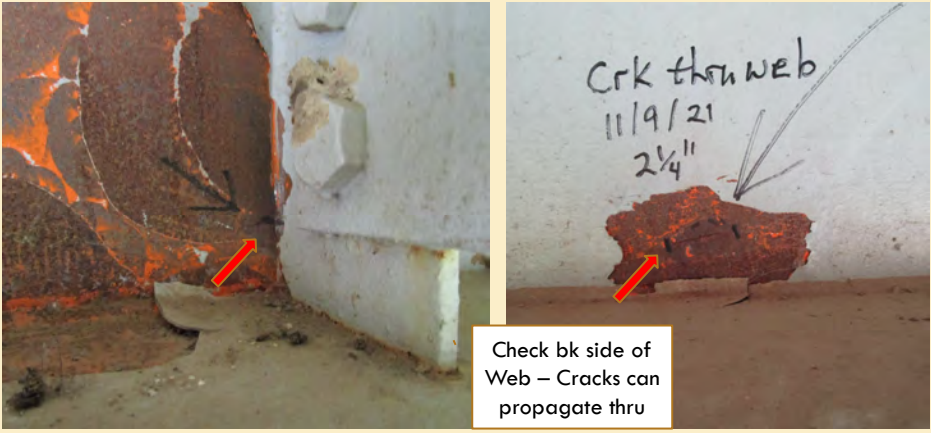
#### Where to Look – Cross Frames & Diaphragms

Crk thru web  
11/9/21  
2 1/4"

Check bk side of Web – Cracks can propagate thru

**POOR** Cross Frame/Diaphragm connection PL details – cracks at ends of PL in tension zones

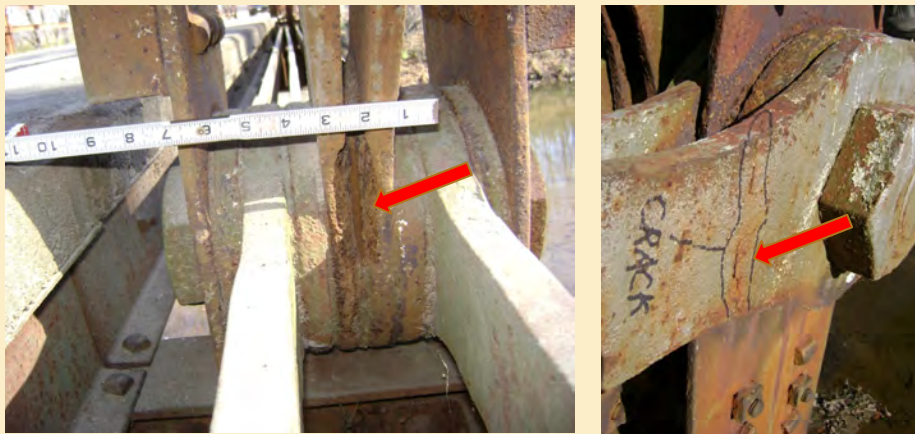
I-28

### Where to Look – Eyebars:

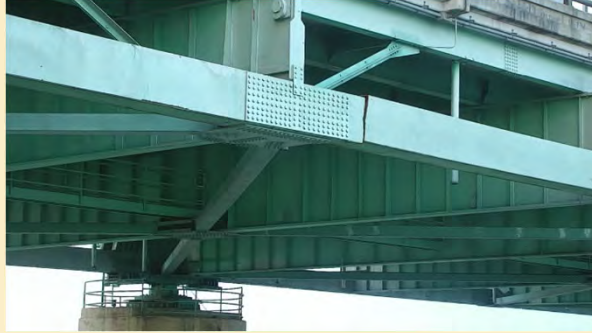
I-29

### Recent Case: I-40 over Mississippi R. at Memphis

- May 2021, fracture of lower truss cord discovered during inspection
- Interstate closed due to severity
- Crack may have been present for a few years!
- Inspector from previous inspection cycles fired. Claimed it was a difficult to reach location.

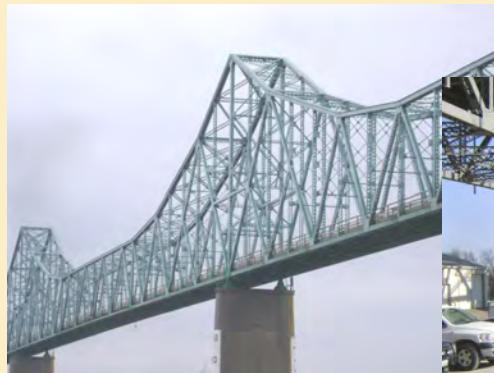
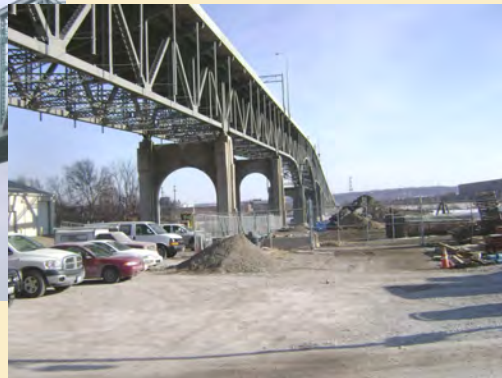
I-34

### BACKGROUND: GP Locations & Numbers

840 Gusset Plates

596 Gusset Plates

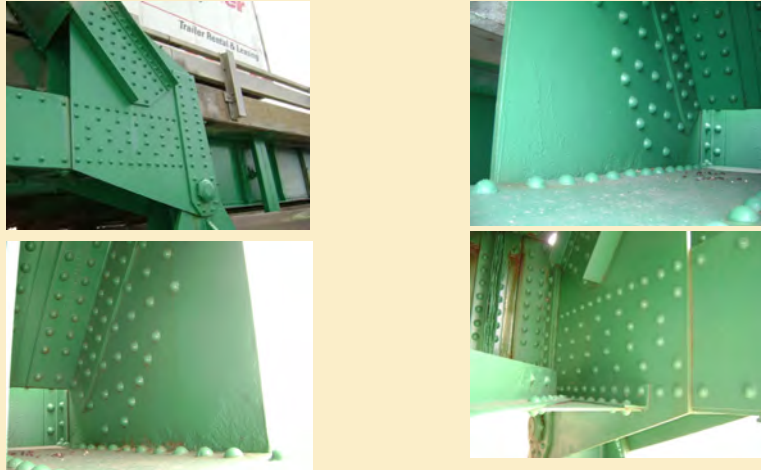
I-37

### Field Photos: GP in good condition

- Condition varies depending on location
- Age & maintenance history important factors
- Locations above “splash line” generally good
- Locations below the splash line more susceptible
- Areas at PL or member connections more susceptible

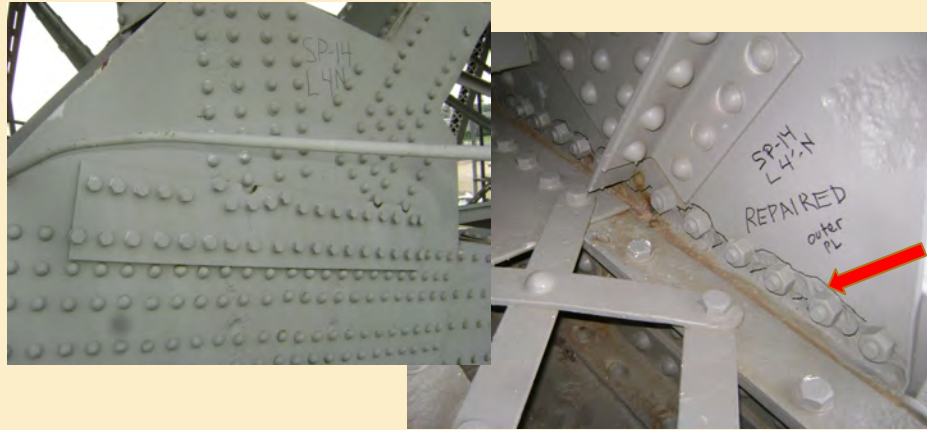
I-41

### Field Photos: Poor repairs
